## **PRE-PURCHASE CONDITION SURVEY REPORT**

### **SAILING BOAT " MISTY SEA "**

NAME OF VESSEL /REGIST. : **MISTY SEA / K-03722**

PLACE OF SURVEY : **ACY MARINA POMER , POMER , CROATIA , EUROPE**

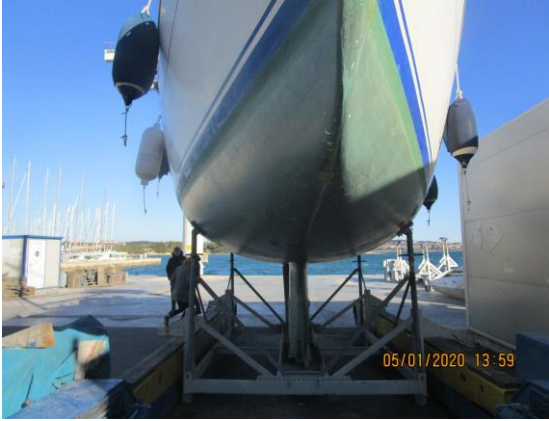
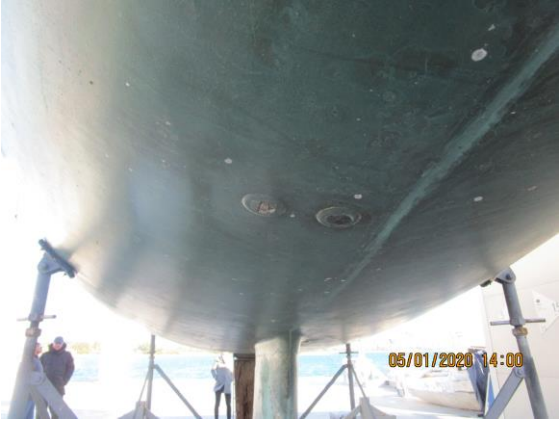
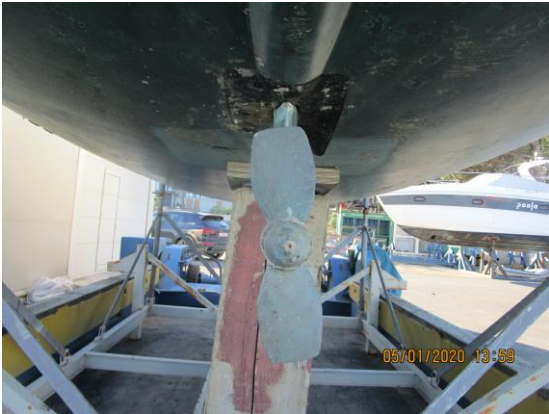
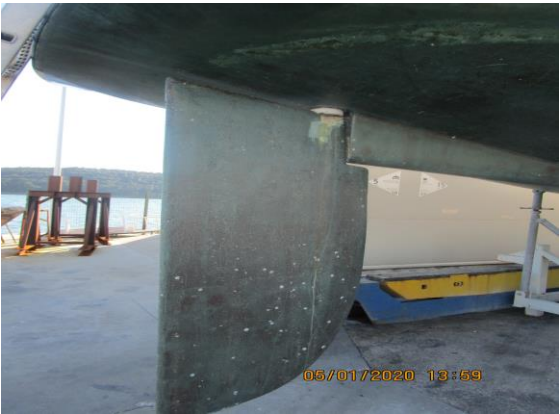
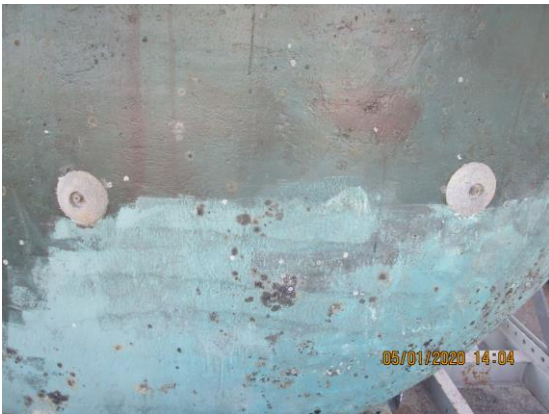
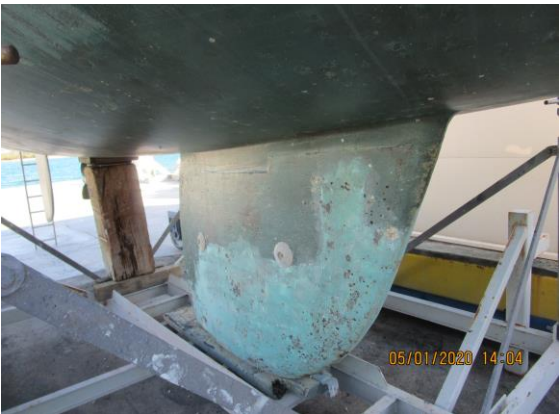
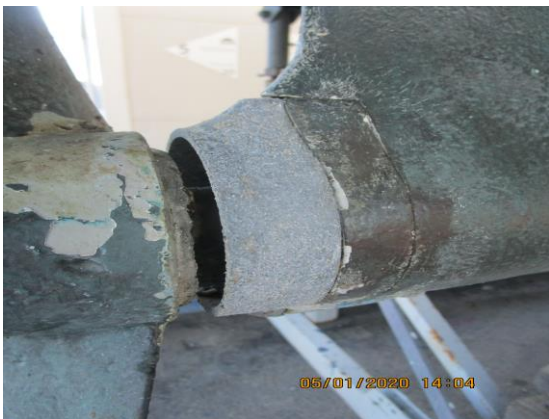
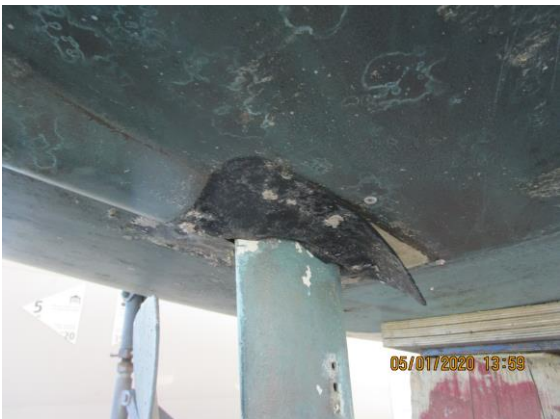
**4.HULL BELOW WATERLINE**

Item	Condition	Amplification
Hull lines	<b>S</b>	
Coating(s)	<b>S</b>	
Damage or repair	<b>NO</b>	
Keel to hull joint	<b>S</b>	
Keel	<b>S</b>	
Rudder	<b>S</b>	replaced in 2018. year
Play in rudderstock bearing ( s )	<b>S</b>	
Propeller shaft	<b>S</b>	clearance to hull appropriate
Strut	<b>S</b>	
Propeller	<b>S</b>	
Bowthruster	<b>N</b>	
Trim tabs	<b>N</b>	
Skin fittings	<b>S</b>	
Cathodic protection	<b>S</b>	5 pieces in good condition
Other defects	<b>N</b>

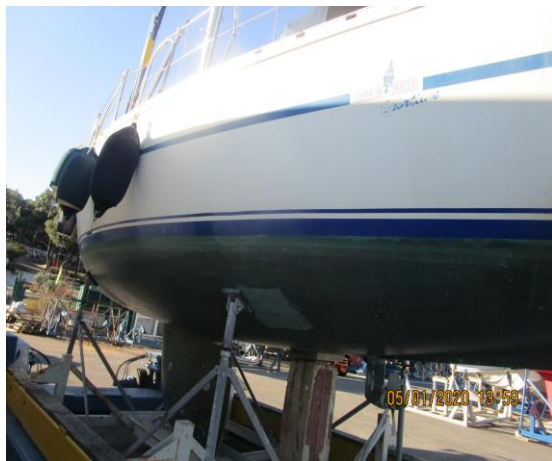
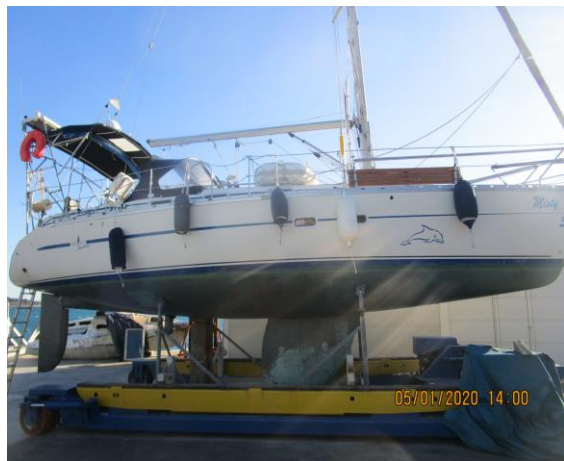
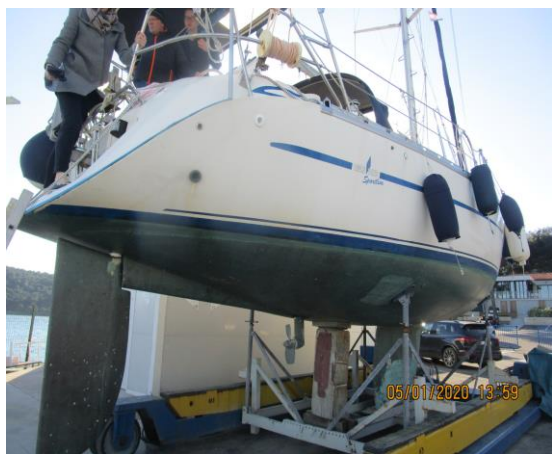
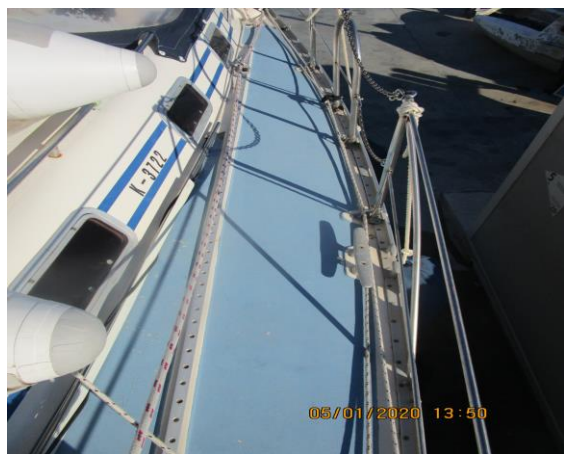
**5.HULL ABOVE WATERLINE**

Item	Condition	Amplification
Hull lines fair	<b>S</b>	
Damage or repair	<b>NO</b>	
Coatings	<b>S</b>	
Rub rail	<b>S</b>	
Gunwale	<b>S</b>	
Hull/Deck joints	<b>S</b>	
Other defects	<b>N</b>

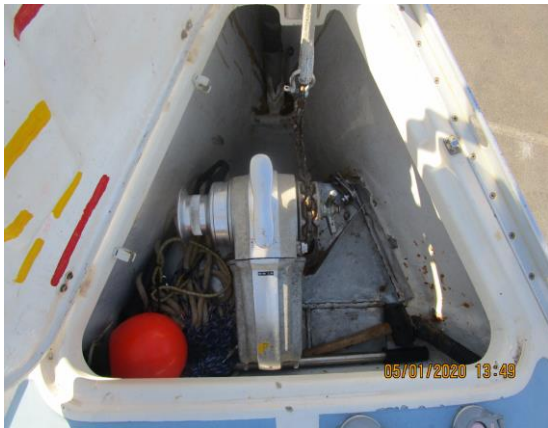
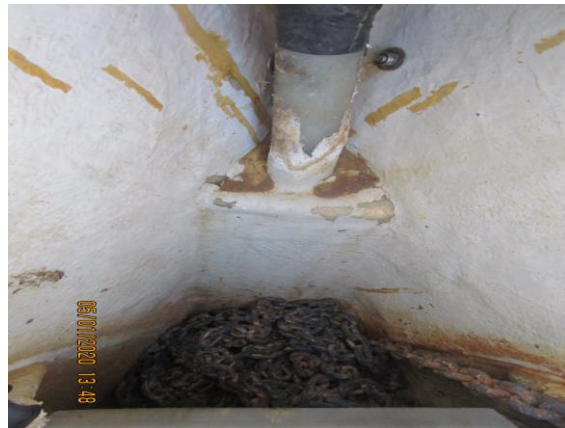
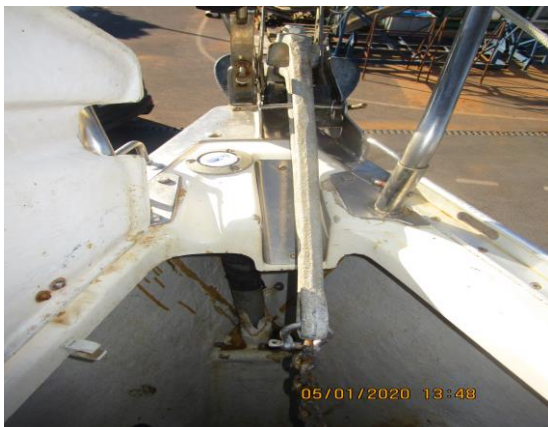
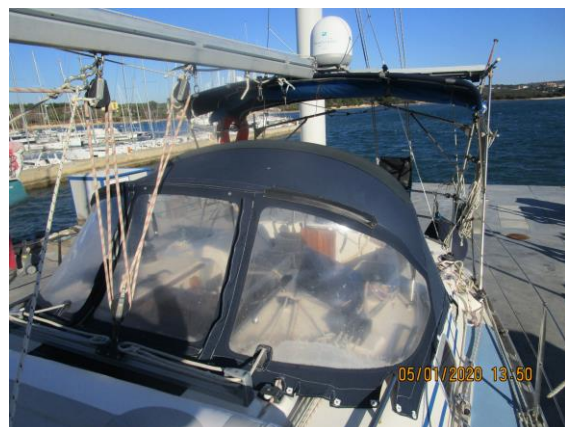
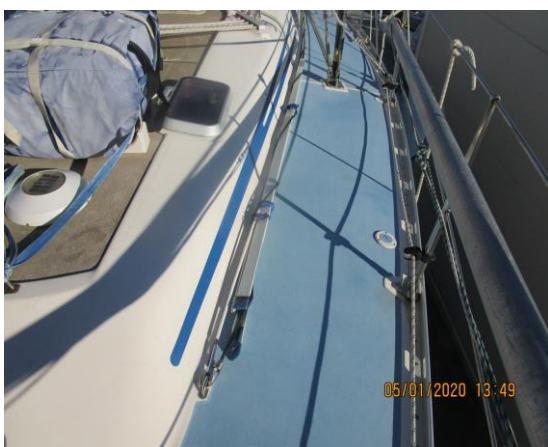
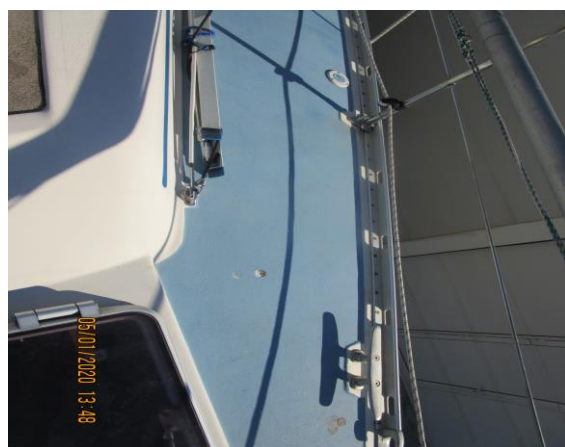
**6.DECK,SUPERSTRUCTURE AND COCKPIT**

Item	Condition	Amplification
Material	<b>S</b>	
Coatings on deck	<b>S</b>	
Deck covering	<b>S</b>	spray hood and bimini top
Deck fittings	<b>S</b>	
Superstructure coatings	<b>S</b>	
Superstructure doorways	<b>S</b>	
Cockpit coating	<b>S</b>	
Bathing platform	<b>N</b>	
Passerelle	<b>S</b>	
Cranage	<b>N</b>	
Winches	<b>S</b>	
Cockpit drains	<b>S</b>	
Anchor and chain	<b>S</b>	length of the chain is 50 m
Chain locker	<b>S</b>	
Windlass(elect. and manual)	<b>S</b>	
Hatches/windows,portlights	<b>S</b>	minor leakages on window
Mast step	<b>S</b>	
Pulpit,pushpit	<b>S</b>	
Guardrail	<b>S</b>	
Companionway to flybridge	<b>N</b>	
Flybridge	<b>N</b>

Flybridge equipment & fittings	<b>N</b>	
Radar arch & equipment	<b>N</b>	
Other defects	<b>N</b>

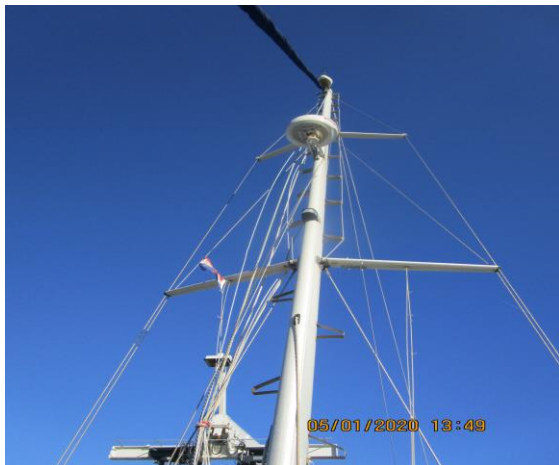
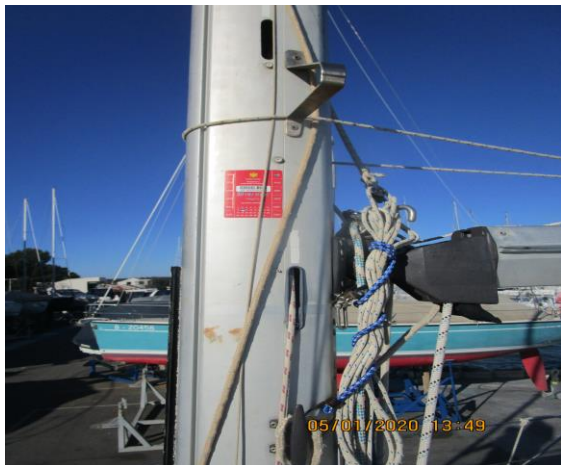
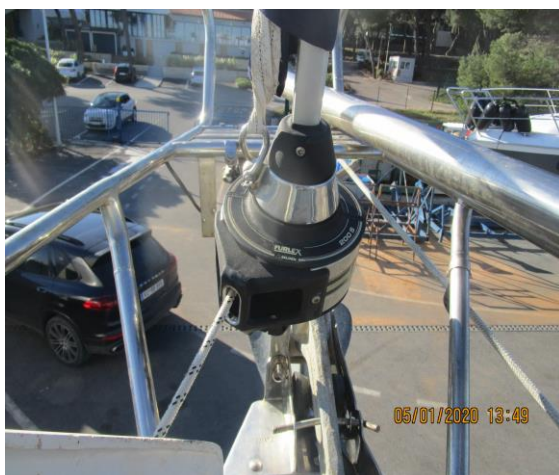
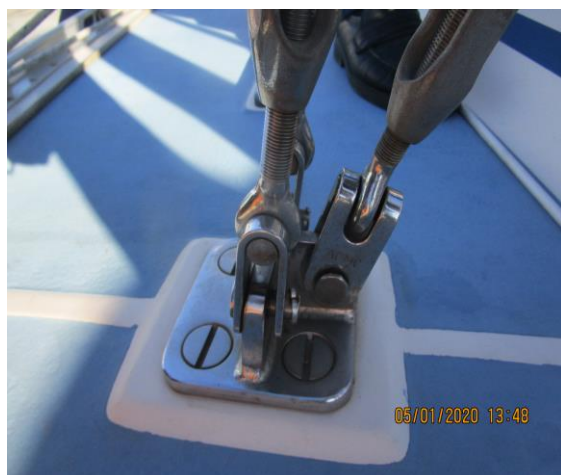
**7.SPARS AND RIGGING**

Item	Condition	Amplification
Mast	<b>S</b>	
Boom	<b>S</b>	
Winches	<b>S</b>	
Rigging	<b>S</b>	
Sails (main,genoa)	<b>S</b>	seen not extended
Other	<b>N</b>

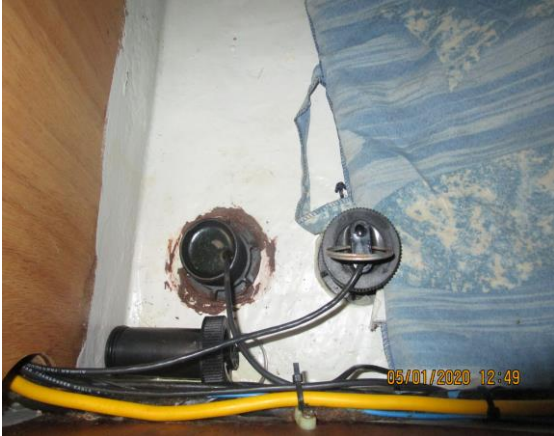
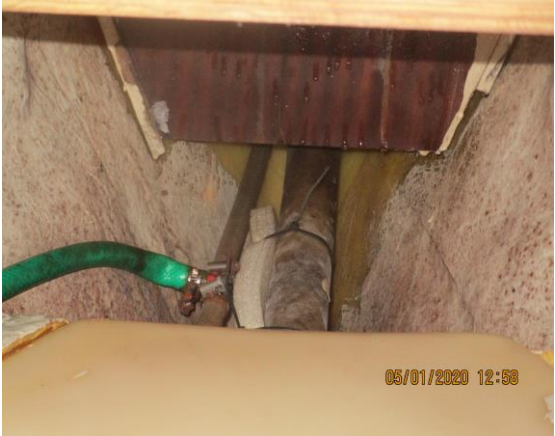
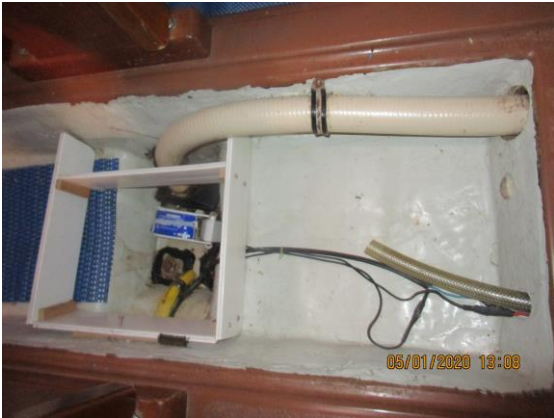
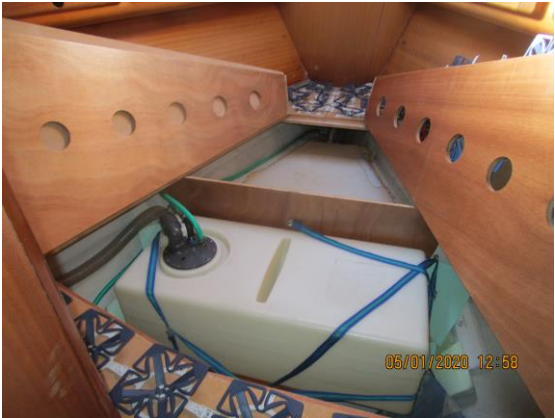
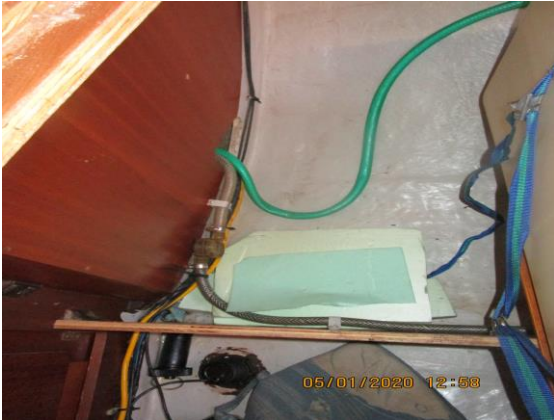
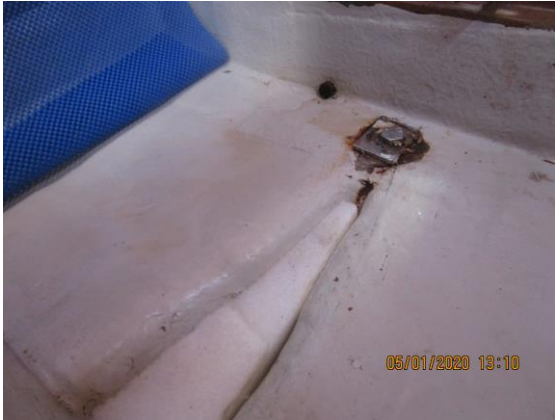
**8.HULL INTERNALS**

Item	Condition	Amplification
Access to hull internally	<b>S</b>	
Coating	<b>S</b>	
Corrosion/rot	<b>N</b>	
Delamination	<b>N</b>	
Bulkheads,frames,stringers, longitudinals	<b>S</b>	
Hull fittings	<b>S</b>	
Sea valves	<b>S</b>	
Hoses and hose clamps	<b>S</b>	
Chainplates	<b>S</b>	
Mast heel/support	<b>S</b>	
Water in bilge	<b>NO</b>	
Keel bolts	<b>S</b>	
Hull/deck joint	<b>S</b>	
Other defects	<b>N</b>

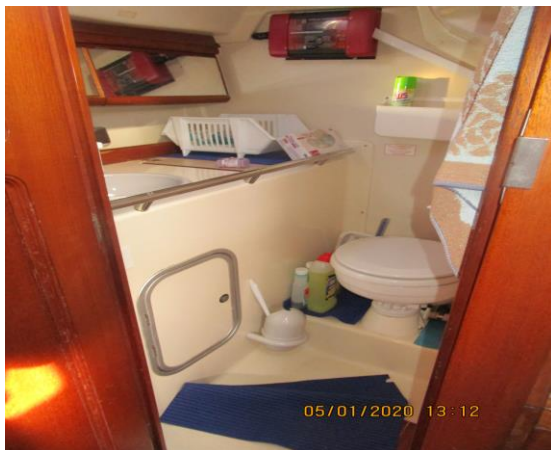
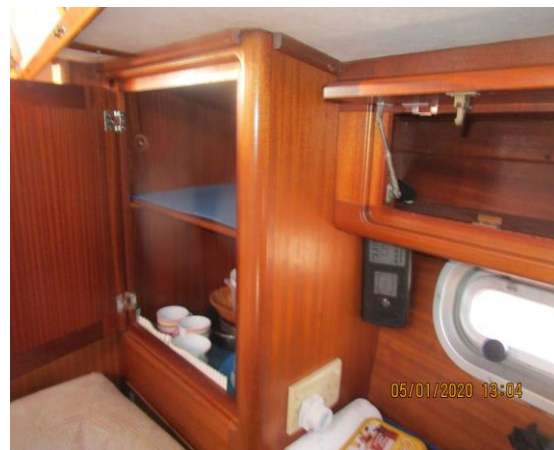
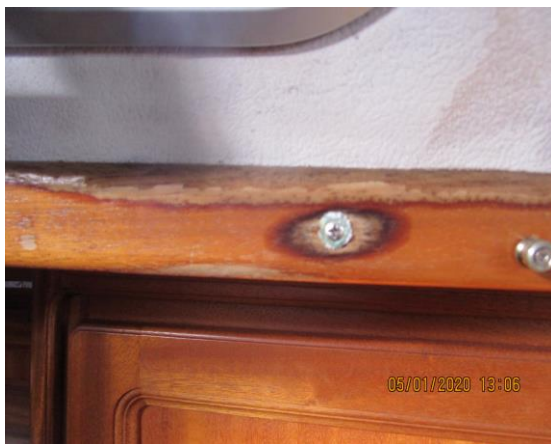
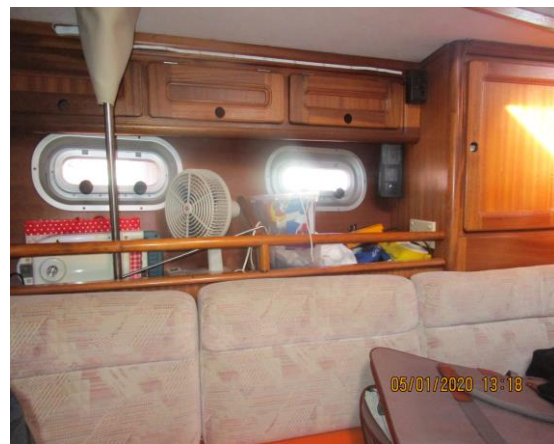
**9.INTERIOR**

Item	Condition	Amplification
Joinery	<b>S</b>	little damage below window
Brightwork	<b>S</b>	
Leaks	<b>NO</b>	
Hinges and locks	<b>S</b>	
Linings	<b>S</b>	
Upholstery	<b>S</b>	
Sea toilet	<b>S</b>	one
Other defects	<b>N</b>

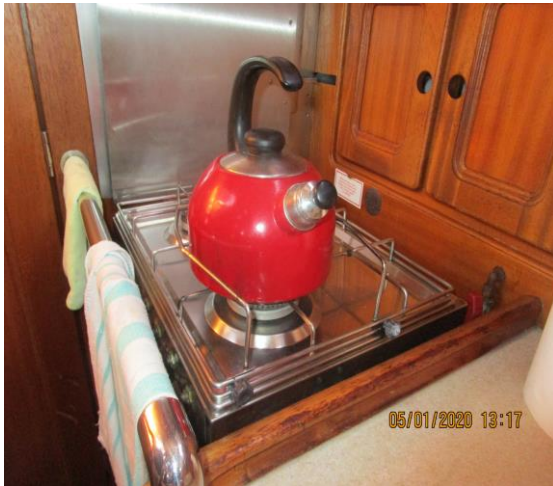
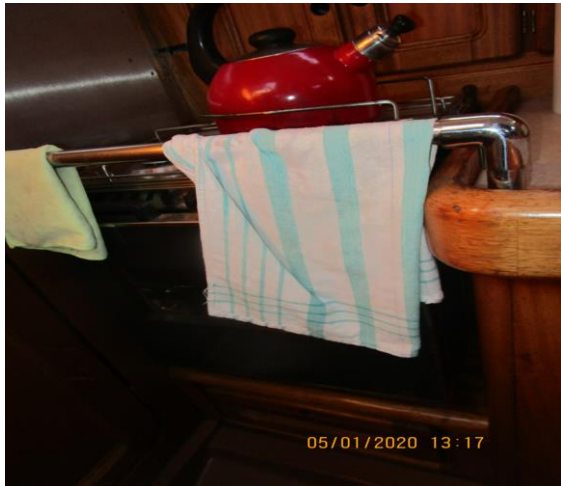
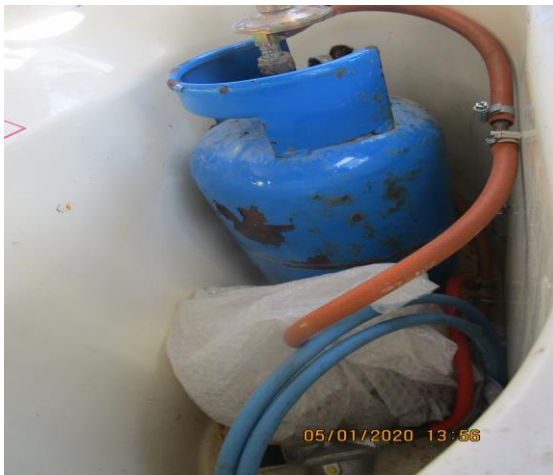
### 11. LIQUIFIED PETROLEUM GAS ( LPG ) INSTALLATION

It is installed LPG instalation for cooking with bottle of 3 kg situated outside on stern.

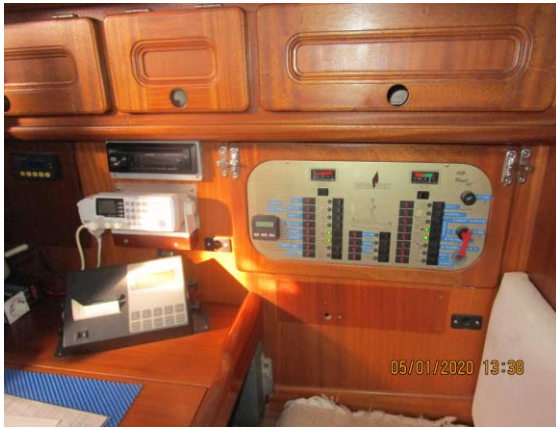
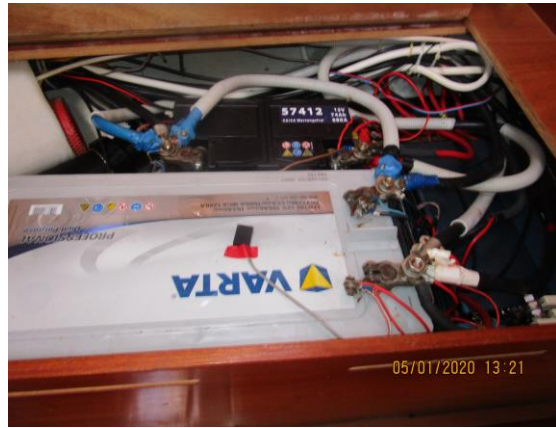
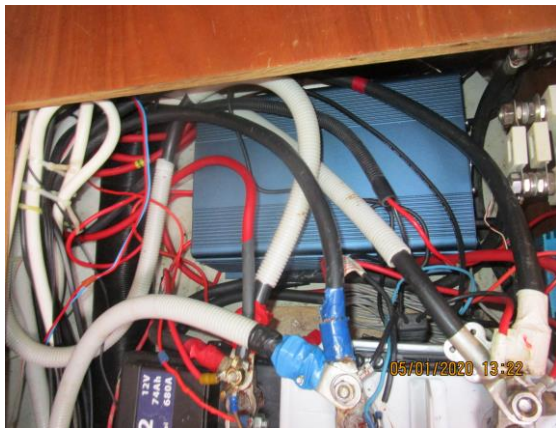
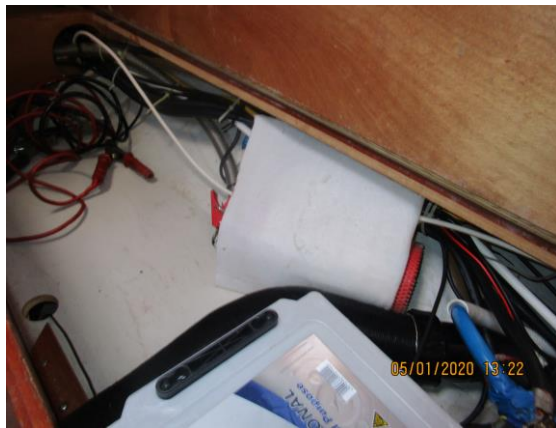
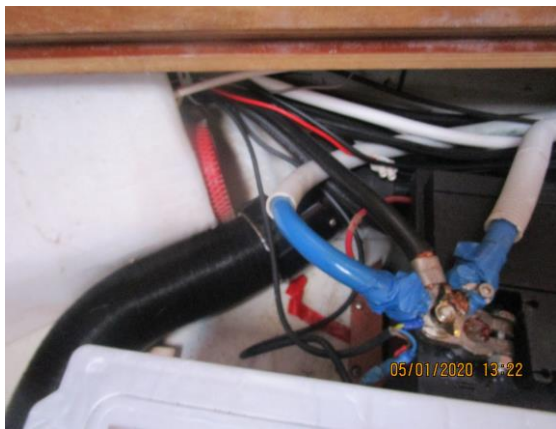
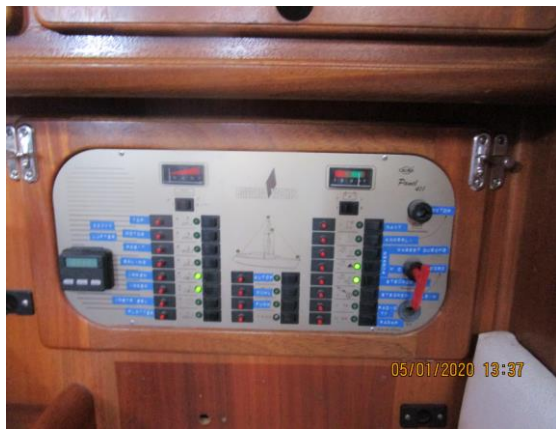
**12.ELECTRICAL INSTALLATION**

Item	Condition	Amplification
DC voltage	<b>S</b>	exist only 12 V voltage
Battery master switches	<b>S</b>	
Master switch fused	<b>N</b>	
Circuits fused	<b>S</b>	
Standard of wiring	<b>S</b>	
Battery and installation	<b>S</b>	2x160 Ah , 1x76 Ah
Lighting	<b>S</b>	
Navigation lights	<b>S</b>	
Shore power connection	<b>S</b>	
Inverter	<b>N</b>	
Battery charger	<b>S</b>	
Generator	<b>N</b>	
Other defects	<b>N</b>

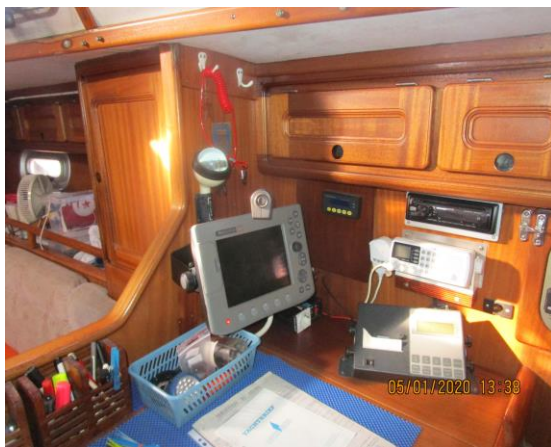
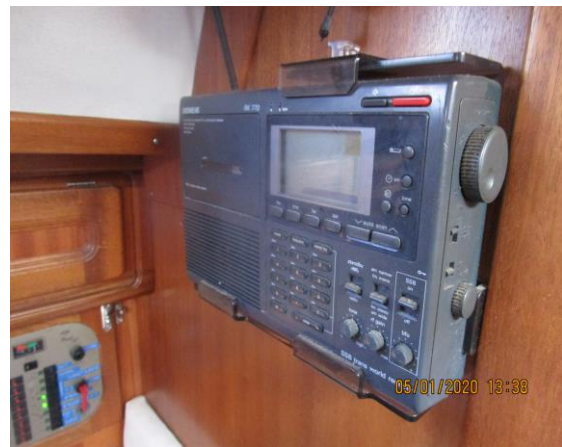
**13. ELECTRONIC EQUIPMENT**

Item	Condition	Amplification
Compass	<b>S</b>	
VHF	<b>S</b>	
Chart plotter	<b>S</b>	
GPS	<b>S</b>	
Log/speed	<b>S</b>	
Navtex	<b>N</b>	
Radar	<b>S</b>	
Autopilot	<b>S</b>	
Radio/CD player	<b>S</b>	
Depth sounder	<b>S</b>	
Wind indicator	<b>S</b>	
Instrument repeaters	<b>N</b>	
Other	<b>N</b>

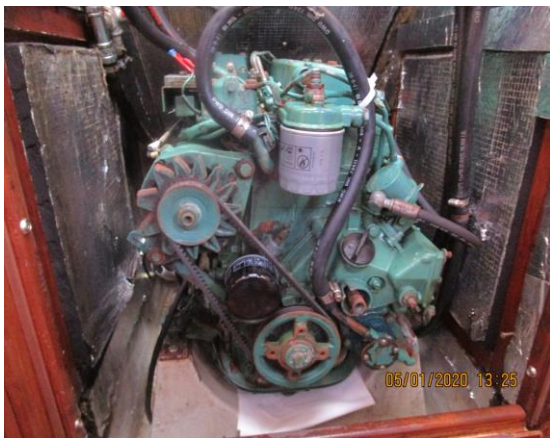
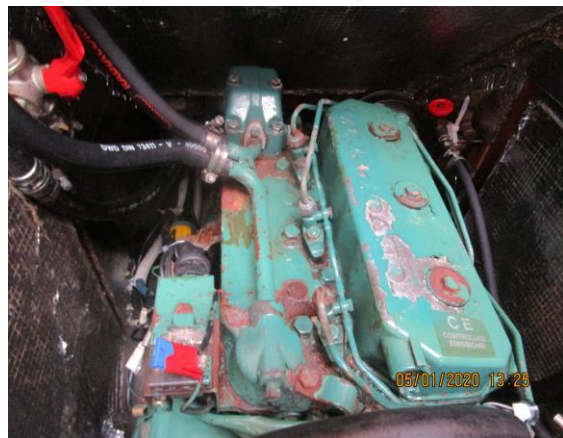
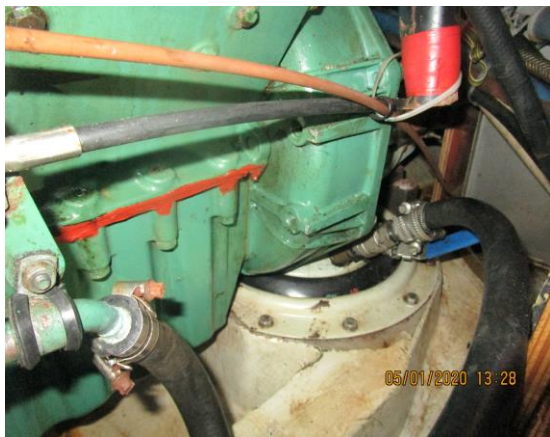
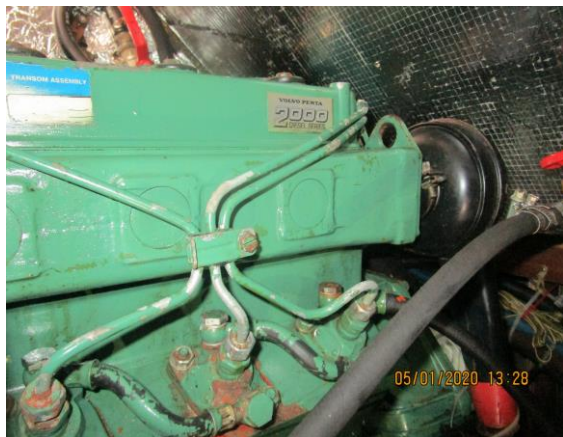
**14. PROPULSION**

Item	Condition	Amplification
Engine manuals on board	<b>N</b>	
Service history available	<b>YES</b>	check all service documents
Engine external appearance	<b>S</b>	
Engine mounts	<b>S</b>	
Vibration dampers	<b>S</b>	
Rigid flexible shaft coupling	<b>S</b>	
Shafting ( where visible )	<b>S</b>	
Shaft seals	<b>S</b>	
Engine beds	<b>S</b>	
Engine leaks - oil	<b>N</b>	
Engine leaks - water	<b>N</b>	
Corrosion	<b>NO</b>	
Transmission	<b>S</b>	
Thrust plate	<b>S</b>	
Cooling system	<b>S</b>	
Seawater strainer	<b>S</b>	
Antisiphon vent	<b>N</b>	
Pipelines	<b>S</b>	
Exhaust system	<b>S</b>	
Muffler/water lock	<b>S</b>	
Exhaust insulation	<b>S</b>

Fuel tank	<b>S</b>	
Fuel filter/ water separator	<b>S</b>	
Fuel shut-off valve(s )	<b>S</b>	
Stern gland leaks	<b>N</b>	
Generator	<b>N</b>	
Oil/water levels	<b>S</b>	
Other defects	<b>N</b>

1.Engine and all saildrive parts have to be general overviewed.

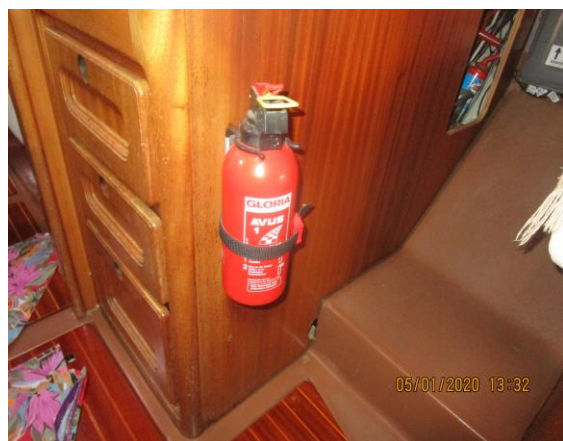
**16.SAFETY AND EMERGENCY EQUIPMENT**

Item	Included on inventory	Amplification
Fire extinguishers	<b>YES</b>	3x2kg,service validity expired
Life raft ( for 6 person )	<b>YES</b>	service validity expired
EPIRB	<b>NO</b>	
Lifeline and quiot	<b>NO</b>	
Lifejackets	<b>YES</b>	for 6 persons
TPAs	<b>NO</b>	
SOLAS signal table	<b>NO</b>	
Pyrotechnics	<b>YES</b>	validity expired
Boarding ladder or equiva - Lent	<b>YES</b>	
Emergency steering	<b>YES</b>	
Bilge pumps	<b>YES</b>	electric and manual
Tender	<b>YES</b>	suzumar with outboard
Other	<b>NO</b>
